# Employing a video probe to measure boiler treatment efficiency in Canada

## Inspecting high heat flux boilers

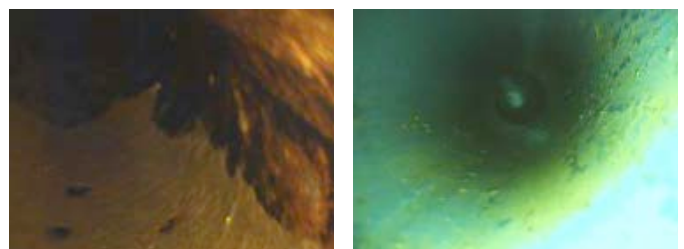
As can be seen from the photo on the left, there was still a considerable amount of scale present. Based on an extensive sampling of the photographs from this inspection, it was clear that about 90% of the heat exchange surfaces had deposits after the first acid cleaning was completed.

*Post-first acid cleaning – 2007      Same boiler – 2011*

As a result of the video inspection, 2 of the 4 boilers had to be cleaned a second time in order to remove the majority of the deposits. However, even with the second cleaning, there was approximately 10–15% of the coil surface that still had scale, which is a testament to the amount of deposit that had accumulated with the previous program.

Combined with better pretreatment control, the plant changed to an all-polymer treatment to minimize the potential for scaling, and by 2011 the tubes were virtually completely free of deposit. In addition to the change to the program chemistry, it was also recommended that

the plant install a condensate polisher. This was done at the end of 2010, and it has eliminated periodic hardness contamination via the condensate returns.
