Evaporator fouling reduction saves ethanol plant \$400k per year!

Background

An ICM 115 MGY ethanol plant was realizing heavy mineral fouling in their evaporators resulting in elevated steam pressures that inhibited the plant from increasing production rates. Sulfuric acid was being utilized to drop the pH in an attempt to alleviate fouling tendencies. Chemical and maintenance costs along with employee exposure to a dangerous chemical were increasing as frequent CIPs and bi-annual hydro-blasting were required to keep the plant operating at less than desired production rates.

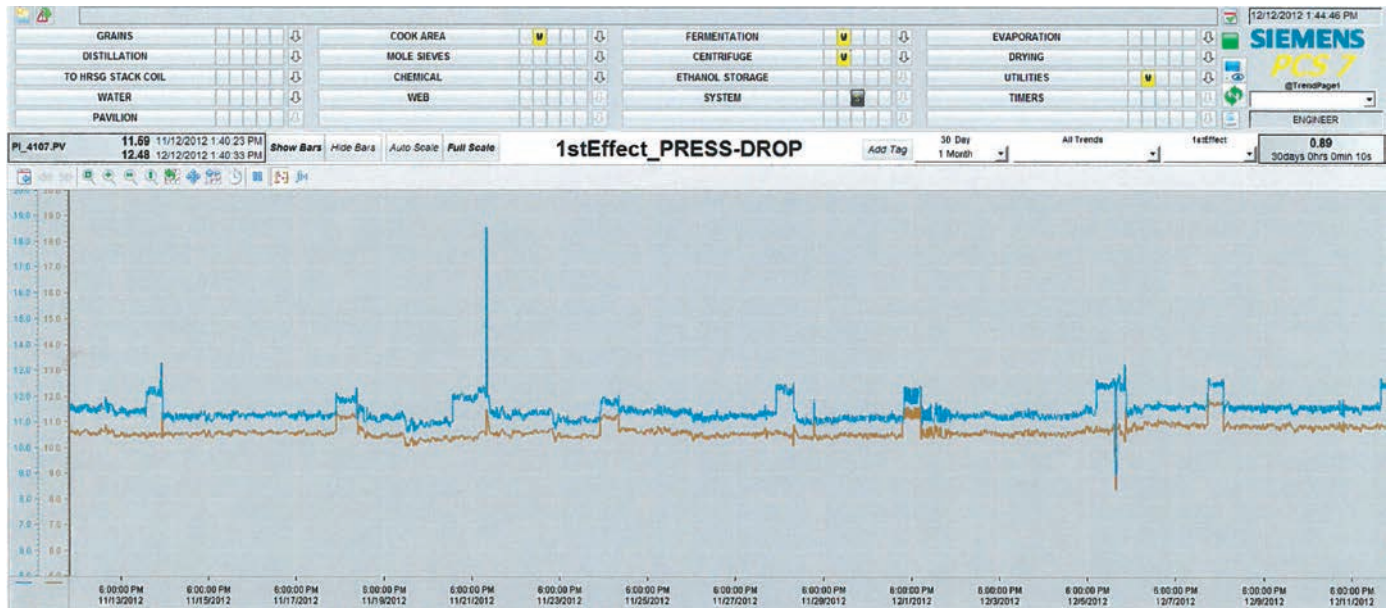
Graph 1. Three-month graph

Graph 1 shows that the plant has settled into a CIP schedule that consists of 2 CIP's/week. When trying to reduce to 1 CIP/week slight pressure increases were realized. The blue line depicts the incoming steam pressure to the 1st effects and the orange line depicts the pressure going to the 2nd effects. Delta P is consistent as steam to the 1st effects was slightly increased near the end of the month. This has been the case at all operational rates across the past three years.

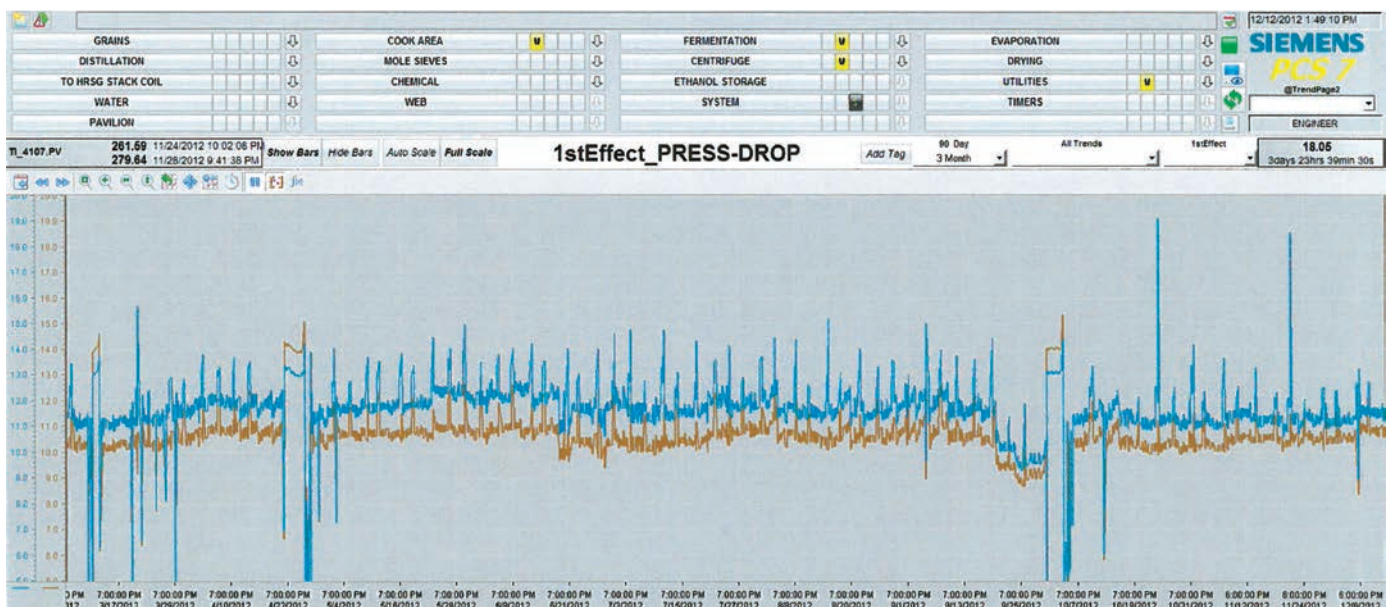
Graph 2. Nine-month graph

Graph 2 shows that even as steam was increased to the first effects in conjunction with increasing plant rate, the pressure to the second effects did not increase, indicating that fouling did not occur or change during that time.

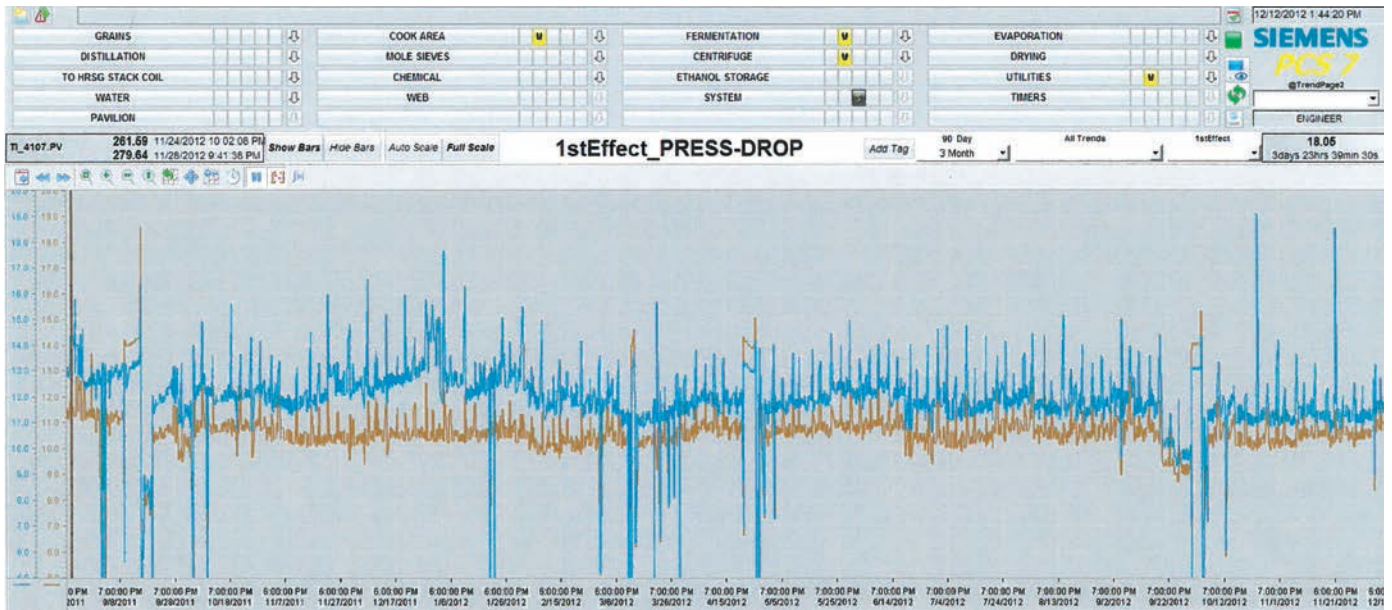
Graph 3. Fifteen-month graph

Graph 3 shows same results as the 15-month graph. (Power outage occurred in December resulting in a degree of fouling as recirculation was off while heat stayed on. A pressure sensor froze up during the month of January.)

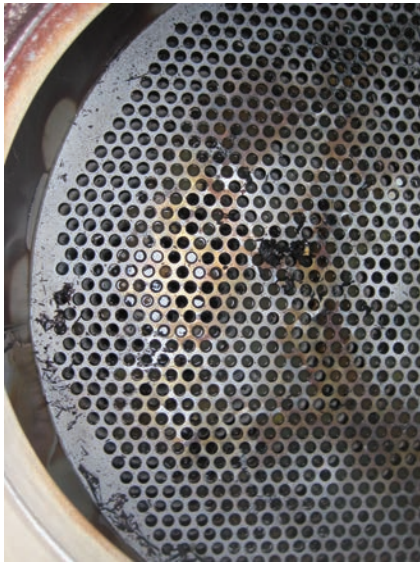
Bulab 8301® does NOT remove existing beerstone – only mitigates the formation of beerstone. Below are before and after pictures of Evaporator #8 tube sheets.

Photo above was taken shortly after beginning usage of Bulab 8301.

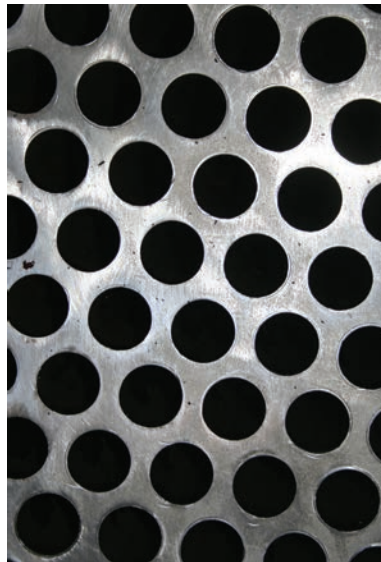
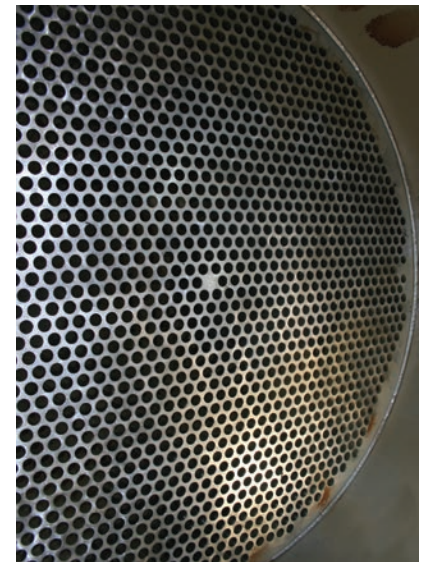
These photos were taken after implementing the Bulab 8301 application with no hydroblasting occurring for 18 months.
